**MEMORANDUM**

**TO: Kusel, Wilson, Round Lakes P & R District**

**SUBJECT: Review of lake management activities on Kusel Lake in 2015.**

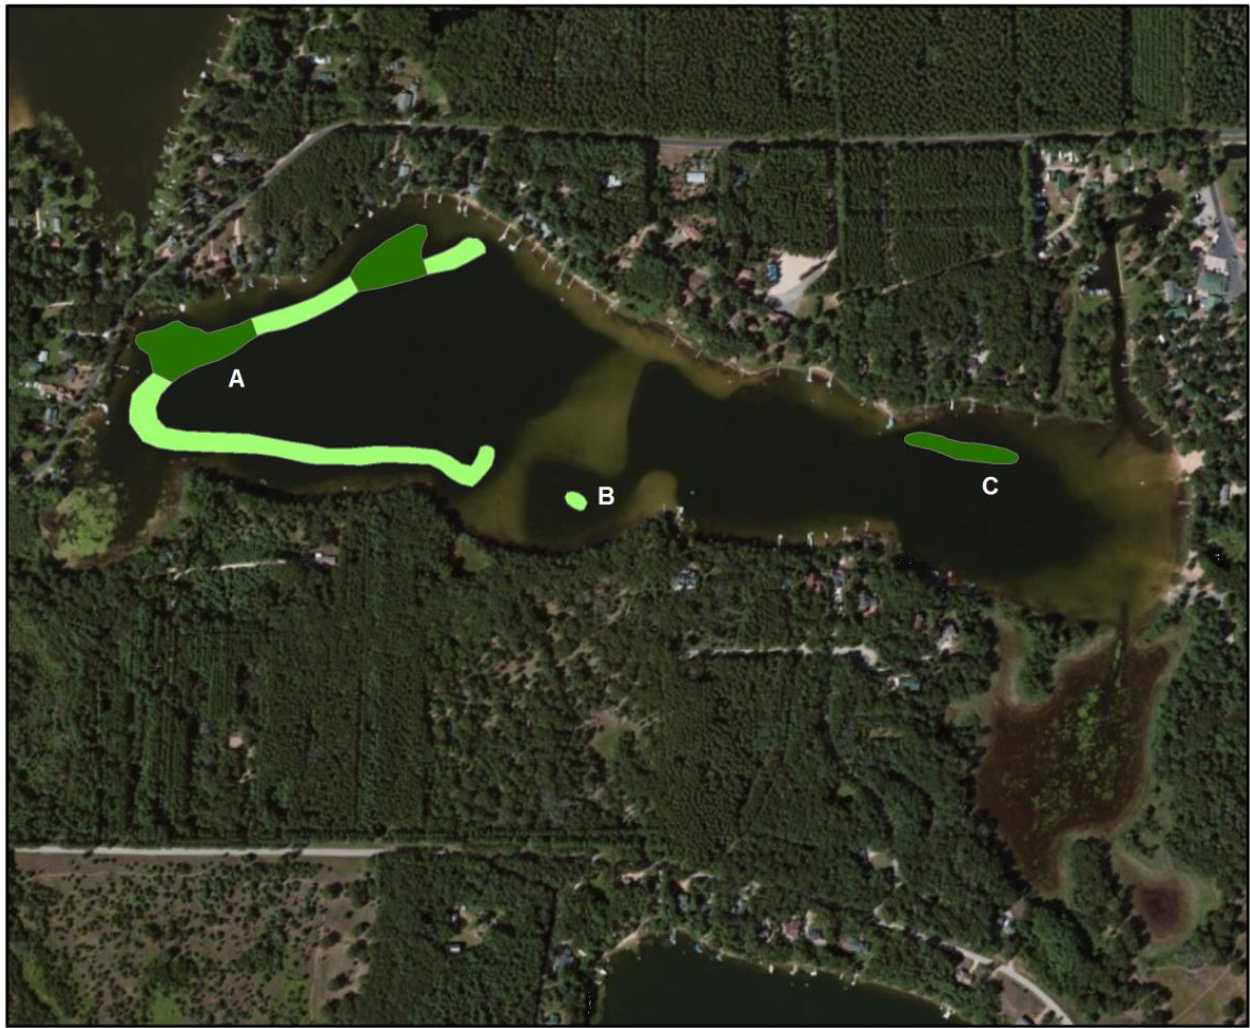
Figure 1. Distribution of hybrid watermilfoil (*Myriophyllum spicatum* x *M. sibiricum*) on October 30, 2014 on Kusel Lake, Waushara County, Wisconsin.

**Kusel Lake EWM 10/30/14**

Moderately dense EWM
-

Scattered EWM

A treatment took place on June 4, 2014 but only in the northeast channel where 0.5 acres of milfoil were targeted with 100 lbs of Navigate<sup>®</sup> applied at a rate of 4.0 ppm (56.8 lbs/acre-foot). On October 30, 2014, an invasive species mapping survey of Kusel Lake found that hybrid milfoil had returned to the main lake, with 6.5 acres being mapped (**Figure 1**). A majority of this milfoil was found in the west half of the lake growing in depths greater than 12 feet. Growth of hybrid watermilfoil had not been seen in these locations for many years. Because of the extent and depth of hybrid watermilfoil found at the time of the survey, a whole-lake low-dose 2,4-D treatment was proposed for the spring of 2015. Permission to conduct this large of a treatment was denied by the Wisconsin DNR until data on the composition of the native aquatic plant community could be collected. As an alternative, permission was given to treat the three densest areas with liquid 2,4-D and endothall, each applied at 1.0 ppm. These areas are shown in **Figure 1**. This treatment took place on May 29, 2015.

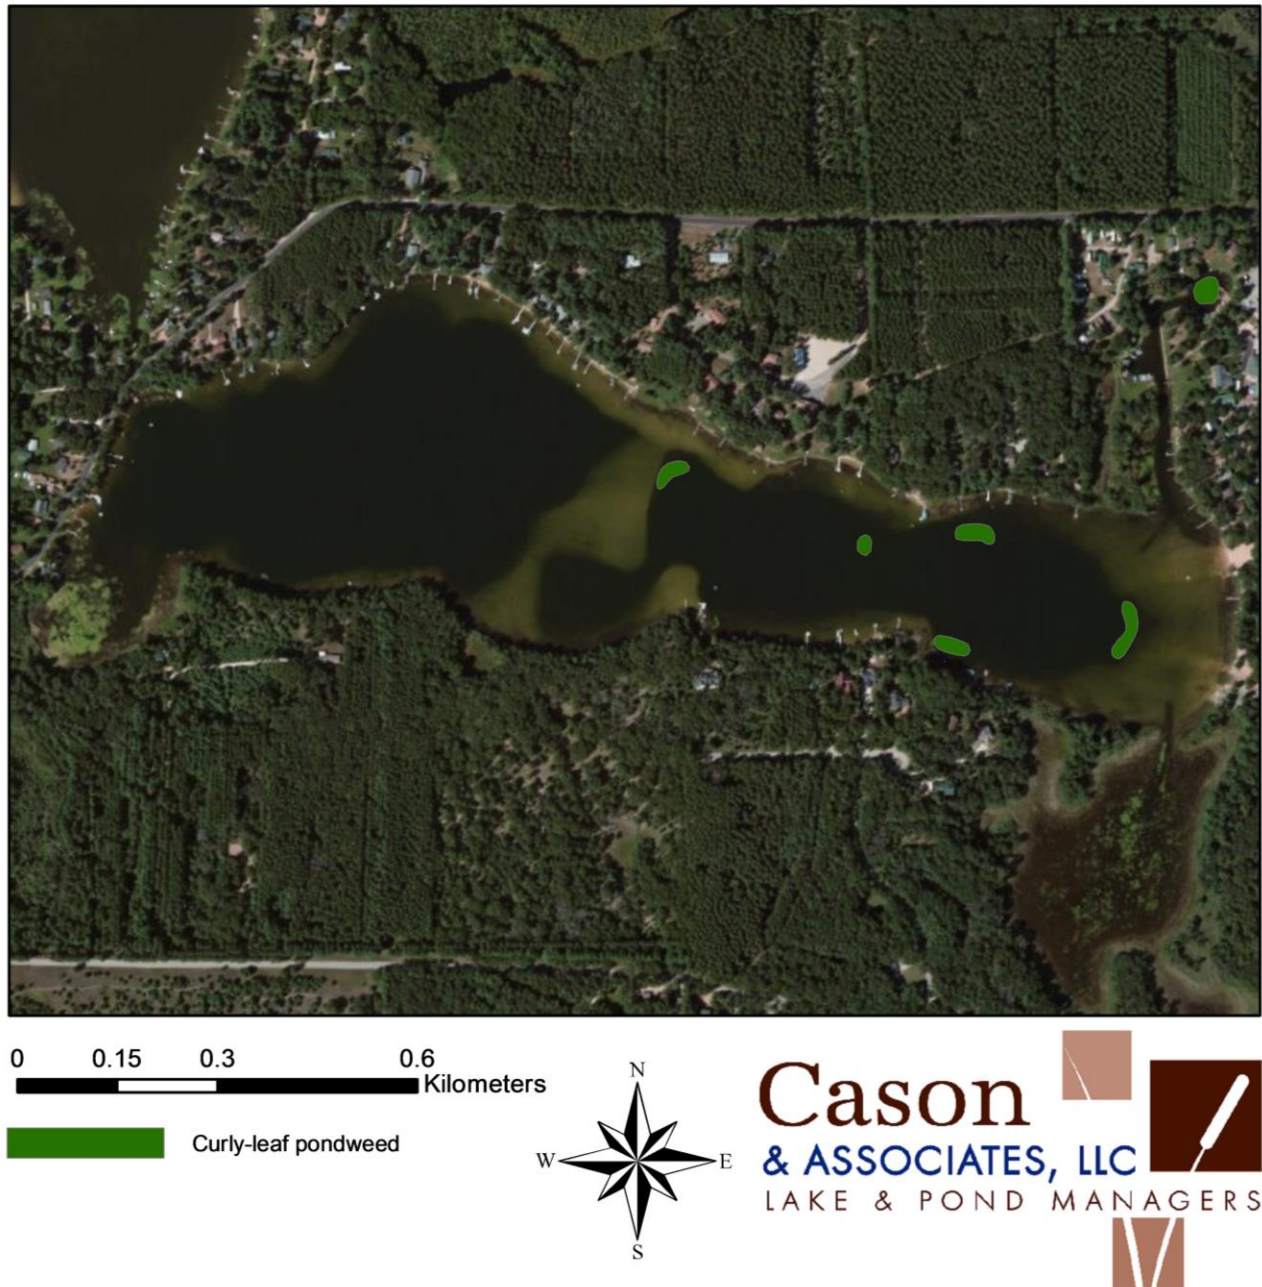
**Figure 3. Distribution of curly-leaf pondweed (*Potamogeton crispus*) on June 2, 2015 on Kusel Lake, Waushara County, Wisconsin.**

During the June 2, 2015 survey, curly-leaf pondweed was identified in six locations in the eastern half of Kusel Lake (**Figure 3**) totaling approximately 0.9 acre. These areas are consistent with the distribution of curly-leaf pondweed over the past decade.
