**KUSEL/WILSON/ROUND LAKES PROTECTION & REHABILITATION DISTRICT  
MINUTES OF BOARD OF COMMISSIONERS MEETING  
December 3, 2016**

**2017 Aquatic Invasive Species Locations**  
Figure 1  
Kusel Lake, Waushara County  
Surveyed: August 8 2017

Proposed 2018 AIS Treatment Areas  
Figure 2  
Kusel Lake, Waushara County  
Surveyed: August 8, 2017

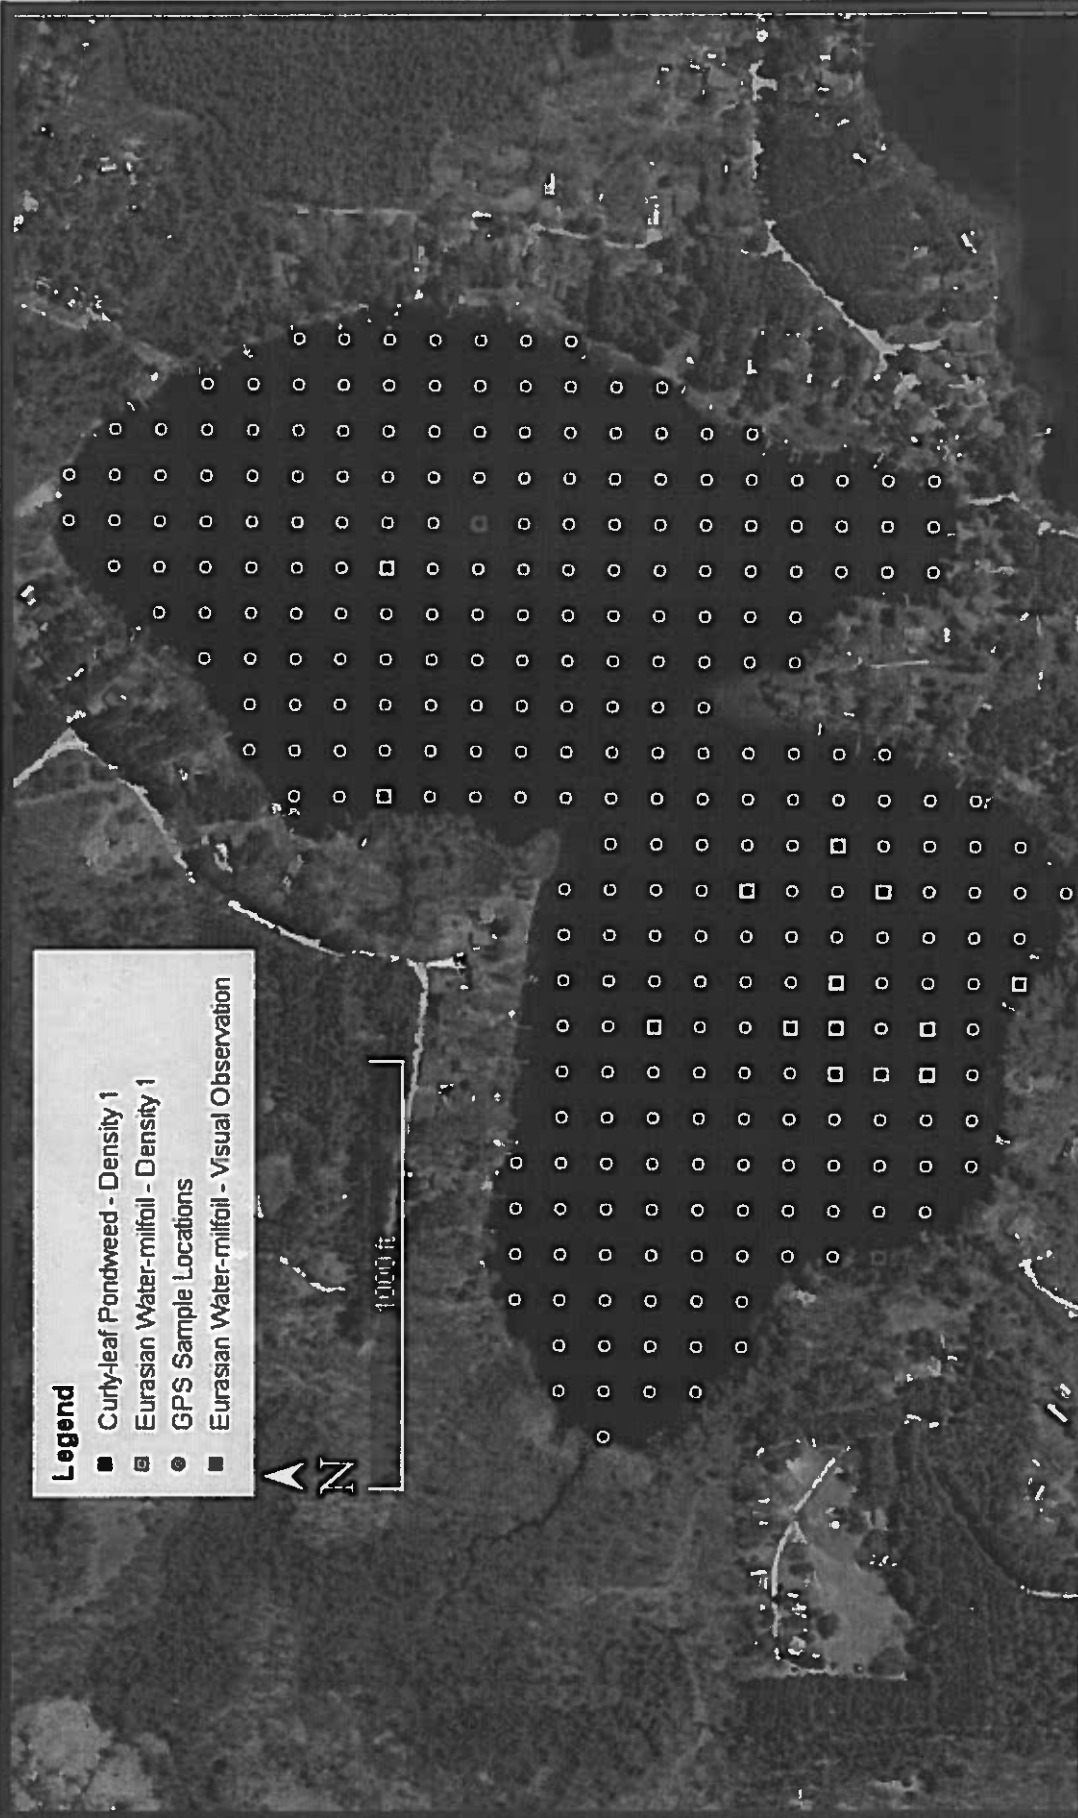
**2017 Aquatic Invasive Species Locations**  
 Figure 3  
 Wilson Lake, Waushara County  
 Surveyed: August 7, 2017

Eurasian water-milfoil was more prevalent here, found at 6.8% of sites with vegetation and mainly located in deeper (8-10 ft), growing densely - this was also noted during aerator cleaning on the lake. Figure 4 shows the areas I would recommend for management in 2018. Aerator locations are found in Figure 5.

**Wilson Lake:** Here too had an overall diverse plant community with 22 total species found, two being invasive. Plants grew to 13 ft here (likely limited by the shallower nature of Wilson compared to Kusel) and were found at 69.3% of locations at this depth or shallower. Muskgrass was also the most common plant found here with common waterweed and white water lily being the next most common. Common waterweed was noted growing very densely in the western portion of the lake and in depth up to 10-12 feet.

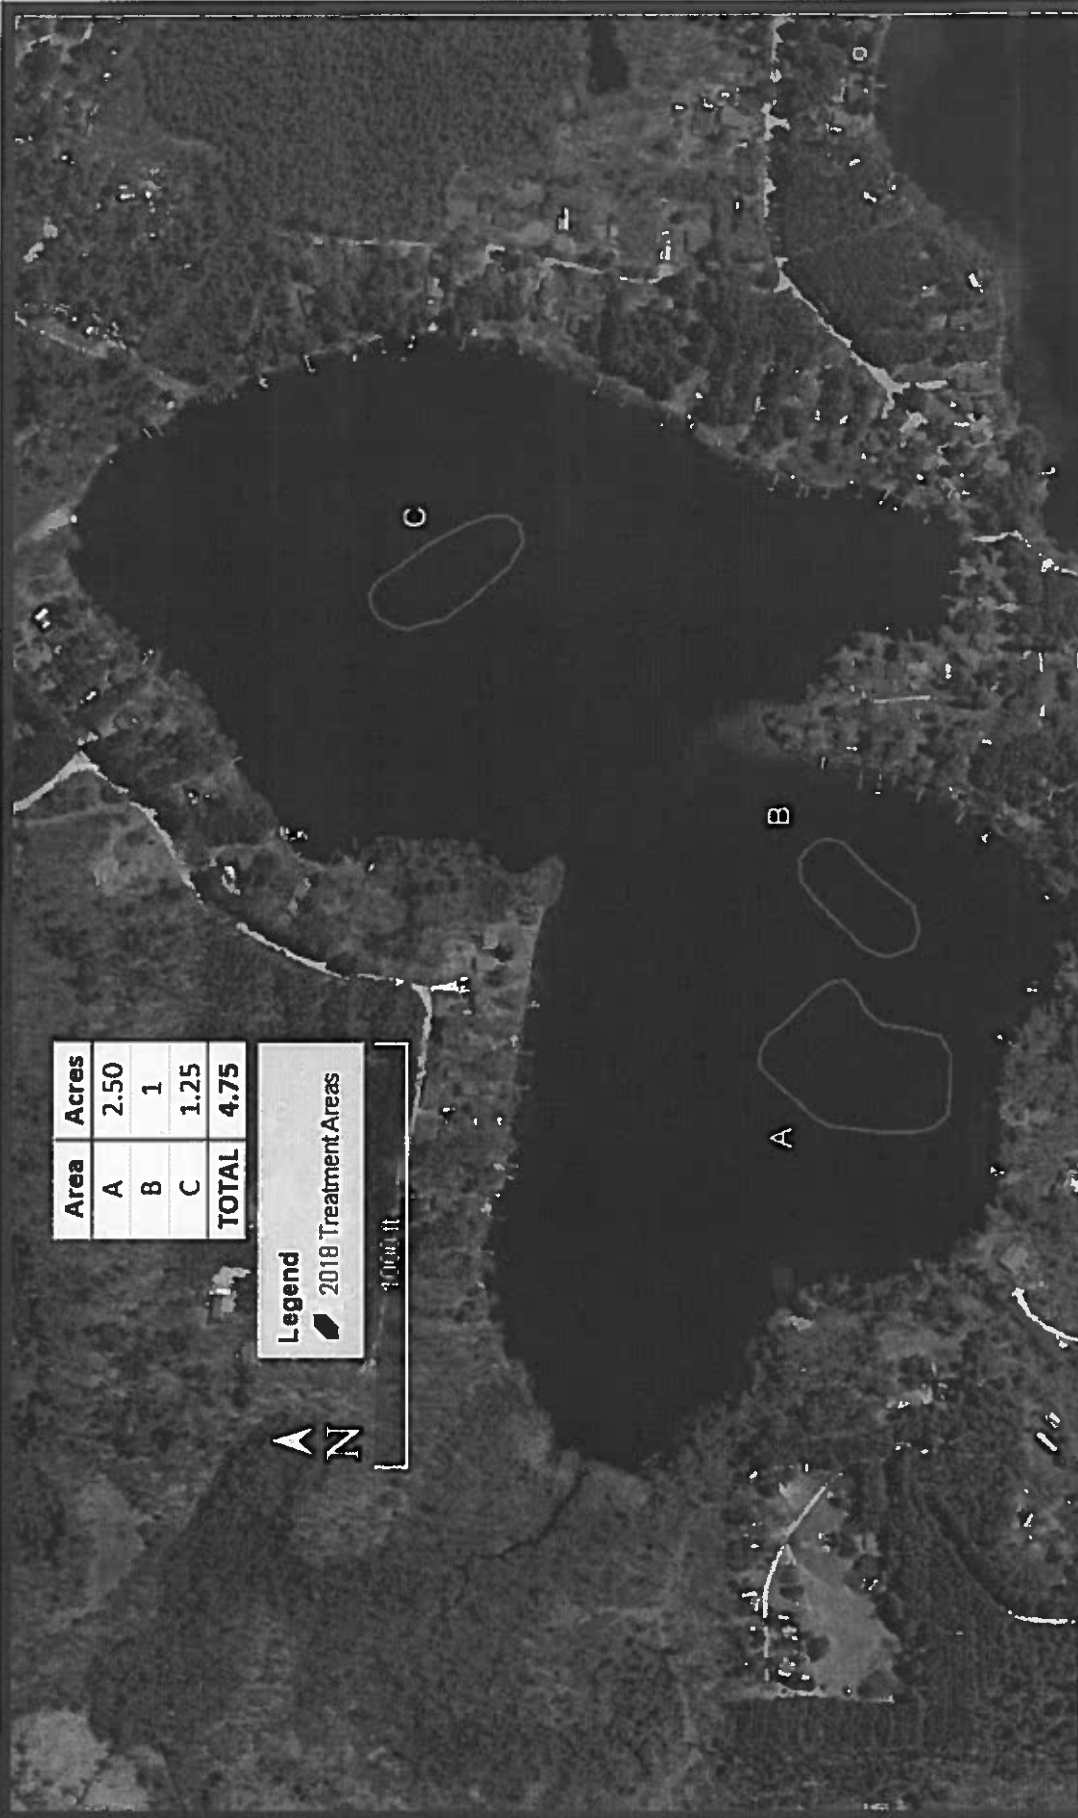
Proposed 2018 AIS Treatment Areas  
Figure 4  
Wilson Lake, Waushara County  
Surveyed: August 7, 2017

Eurasian water-milfoil was more prevalent here, found at 6.8% of sites with vegetation and mainly located in deeper (8-10 ft), growing densely - this was also noted during aerator cleaning on the lake. Figure 4 shows the areas I would recommend for management in 2018. Aerator locations are found in Figure 5.

**2018 AIS Management:** On both I recommend concentrating on larger beds of the target species, leaving the individual satellite locations alone. The reason for leaving the small locations be is that their size is too small relative to the surrounding water volume to achieve desired results. The herbicide would wash out too quickly and not get to desired rates and contact time to be effective. In the deeper areas I would recommend going away from 2,4-D due to a longer required contact time and going with a fast-acting herbicide, such as one containing diquat and endothall, and be completed early in the season. This plan has worked well in similar situations while limiting the impact to non-target native species. Both lakes may also see native vegetation that grows dense enough to become a nuisance to navigation which may need management - we can discuss this later if it's viable.
